OFFICE OF THE SPECIAL INSPECTOR GENERAL FOR AFGHANISTAN RECONSTRUCTION

INSPECTION OF KOHI GIRLS' SCHOOL CONSTRUCTION PROJECT IN KAPISA PROVINCE:

CONSTRUCTION DELAYS RESOLVED, BUT SAFETY CONCERNS REMAIN

SUBJECT: SIGAR Inspection Report 10-4: Inspection of Kohi Girls' School Construction

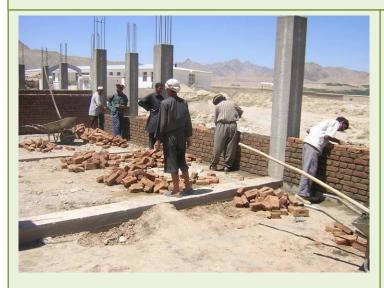
Laborers working to complete the Kohi Girls' School in August 2009. (Photo provided by SIGAR)

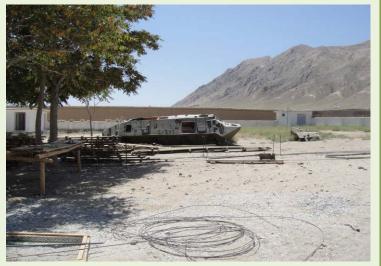
- Presence of War-Related Debris Next to Construction Site: SIGAR noted that the presence of potentially hazardous war-related debris on property that is shared by both the newly constructed girls' school and an adjoining boys' school. Based on discussions with PRT officials, SIGAR believes the debris should have been removed at the start of the project as part of the site preparation phase.

The war-debris filled yard that the Kohi Girls' School shares with an existing boys' school presents hazards to students unless cleared. (Photo provided by SIGAR)

That the Commander, Kapisa PRT, in partnership with the Kapisa Provincial authorities, develop a plan for the removal of war-related debris from areas adjacent to the Kohi Girls' school construction project.

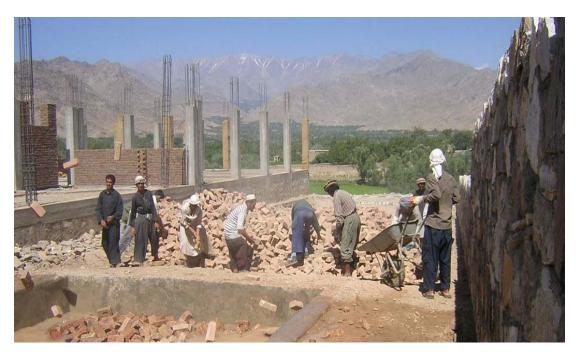
Site Photo 3: Laborers working to complete the Kohi Girls' School in August 2009. Projects such as this one provide legitimate local employment while allowing workers to develop new skills. (Photo provided by SIGAR)

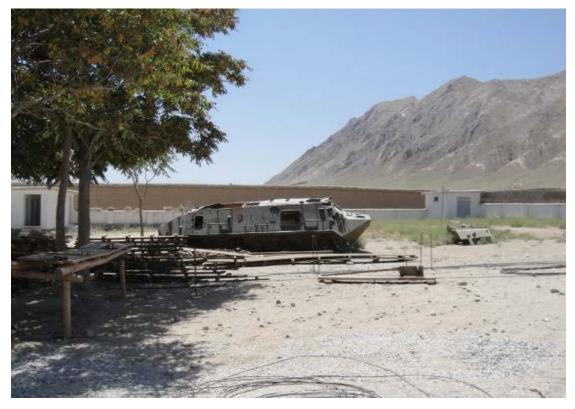
Site Photo 4: A destroyed armored military vehicle and other war-related debris raise concerns of hazardous objects being present on land adjacent to the school construction site. (Photo provided by SIGAR)

SIGAR noted that the school is being built adjacent to an existing boys' secondary school that had been constructed several years earlier by the Afghan government with international donor funds. SIGAR observed extensive debris and rubble on the grounds of the boys' school that was apparently left over from fighting in the area which occurred years earlier and has never been cleared. This school yard will be a shared point of access to both the girls' school and the boys' School once construction is completed. SIGAR observed parts of several destroyed armored military vehicles on this school yard (see Site Photos 4 and 5).

Both the PRT engineer and school officials acknowledged that the presence of such war-related debris raises the possibility that hazards from unexploded ordnance exist and that such debris poses risks to users of both schools. SIGAR asked why such objects had not been cleared earlier as part of the site preparation phase of the project. The School Director stated that removal of such war debris is the responsibility of the Ministry of Defense. SIGAR believes the presence of war-related objects adjacent to the school grounds raises serious safety concerns that should be immediately addressed.

SIGAR recommends that the Commander, Kapisa PRT, in partnership with the Kapisa provincial authorities, develop a plan for the removal of war-related debris from areas adjacent to the Kohi Girls' School construction project.

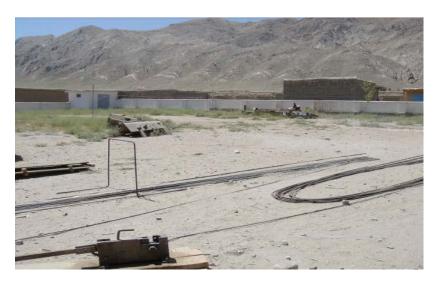
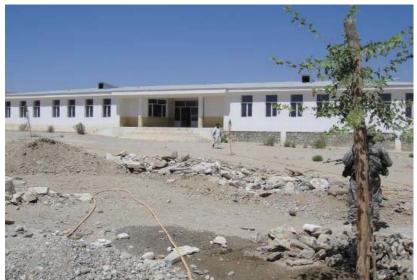
Site Photos 5 and 6: Views of the school yard that the Kohi Girls' School shares with the adjacent boys' school (left). SIGAR believes that the statement of work should have included removal of such hazards. (Photos provided by SIGAR)
